Feasibility
(Section 1135) Report
and
Environmental Assessment

Fish Passage Modification Charles River Dam Boston, Massachusetts

December 1992

US Army Corps
of Engineers
New England Division

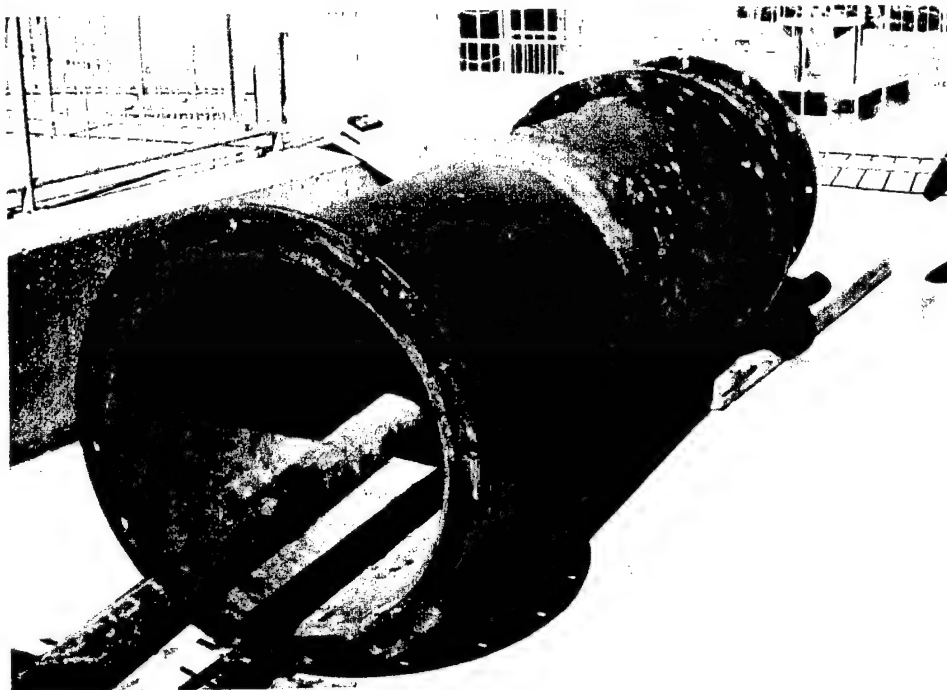
FIGURE 1. Fishway pump outer casing and shaft enclosing tube.

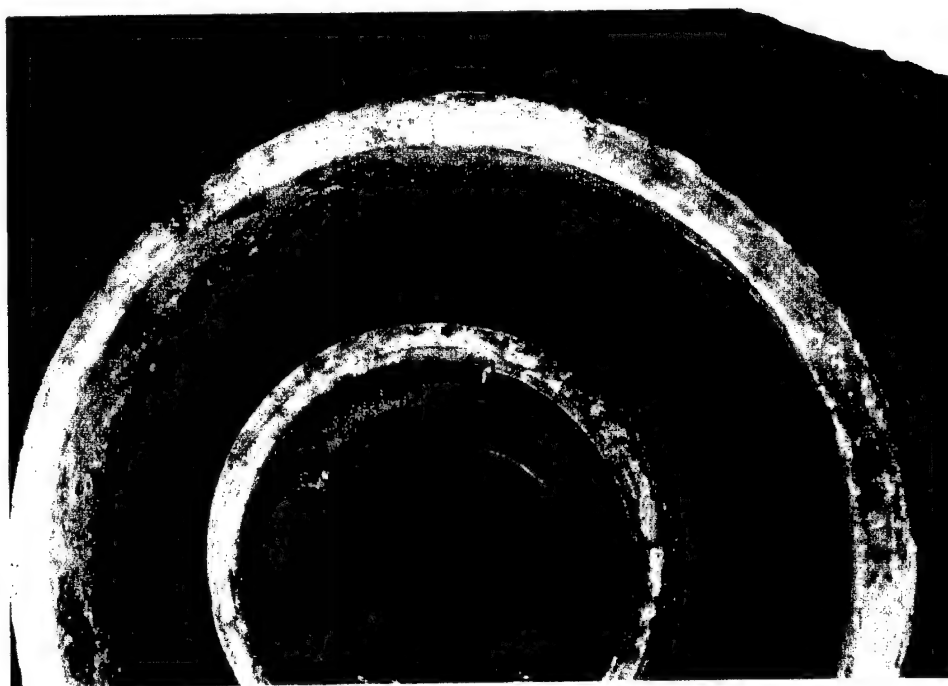
FIGURE 4. Fishway pump suction bell & lower bearing support.

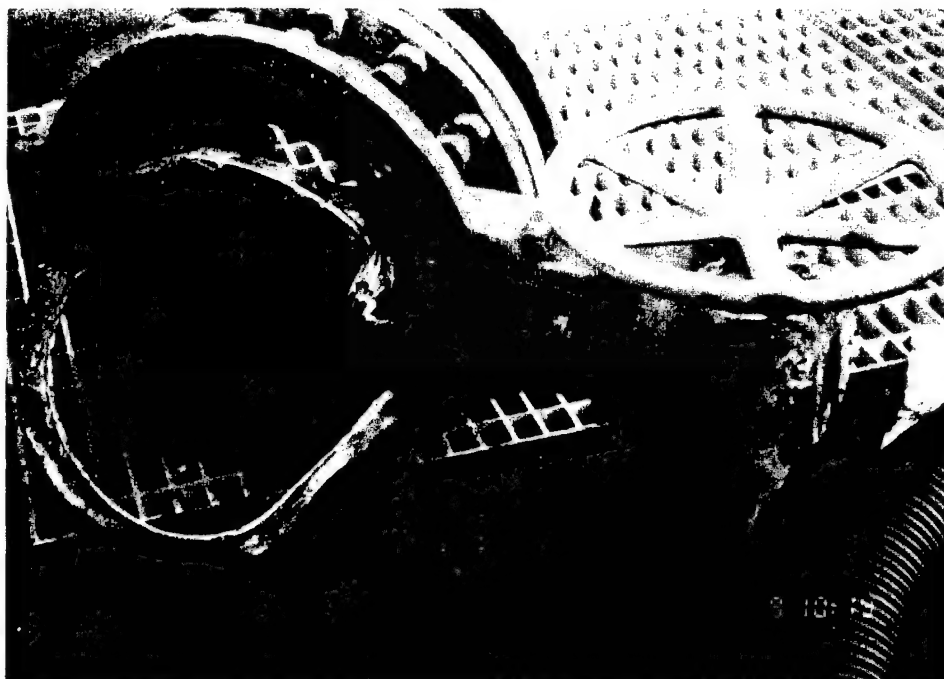
FIGURE 5. Butterfly valve from 20" diffuser line.

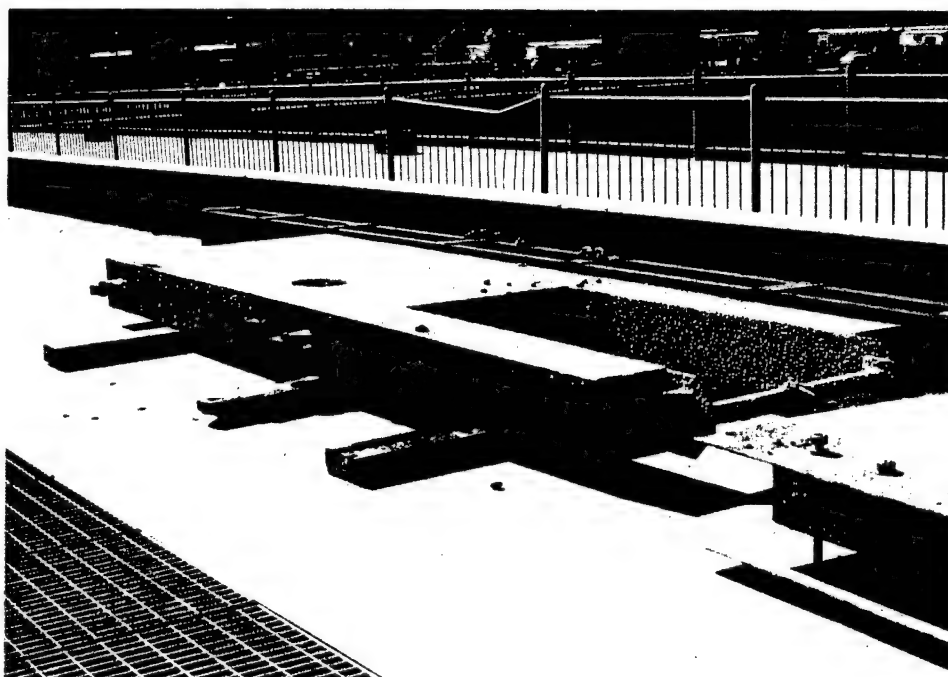
Currently, effective upstream fish passage through the fish ladder is severely limited because the floating weir is damaged and the diffuser pipes are partially blocked. These conditions prevent attraction velocities at the harbor entrance until water levels in the

FIGURE 6. Floating weir, upper section.

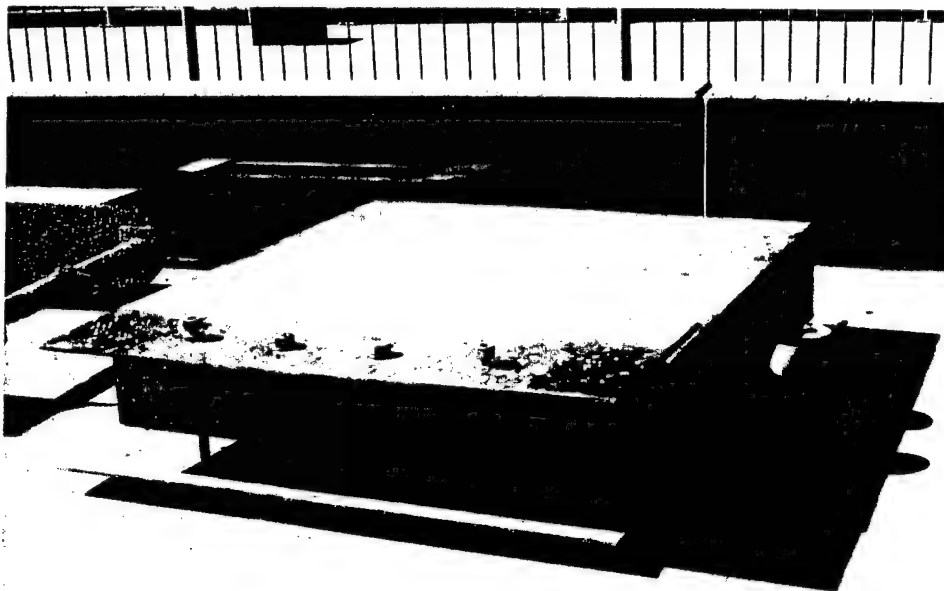
FIGURE 7. Floating weir, lower section.
